**Issue:**

Timeout issue with RMS-MLOG devices.

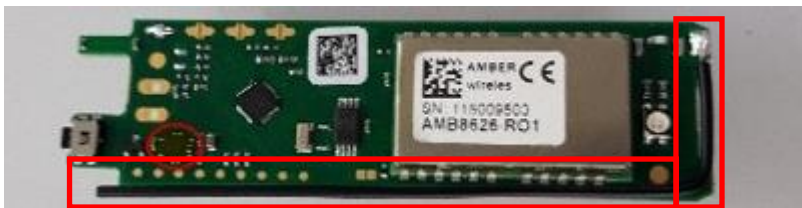
**Default position**

Most of these devices that have reported issues have only been in use at 0 °C or lower. The antenna is near the voltage controller. If the antenna touches this voltage regulator (red marked area on the picture), this leads to an electromagnetic effect, which triggers a voltage drop to 0.6 V. This voltage drop causes the timeout. A low ambient temperature has an additional influence on the power supply of the battery.

To fix this problem, please bend the antenna as per the instructions:
